Manhole Inspection Summary

Manhole # S49K__026MH

Insp Date: **9/9/08 9:55 AM**

Location Address: **rear 714 wagner st**

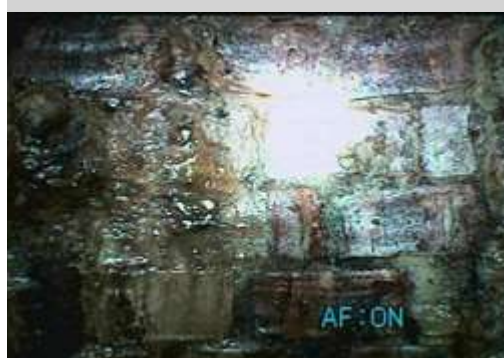
Defect 3

bench debris

barrel infiltration

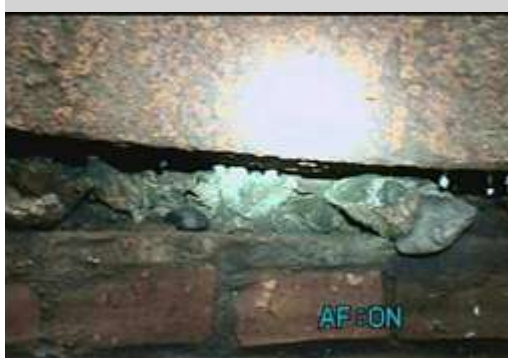
Defect 2

corroded steps

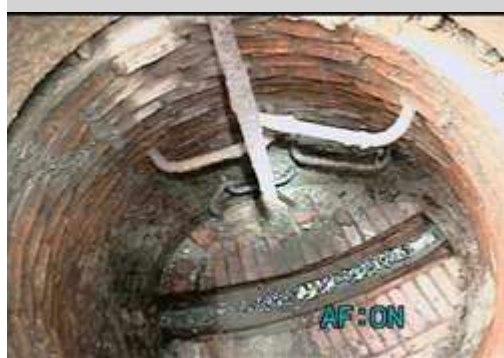
Defect 1

cracked chimney loose bricks deteriorated frame adj

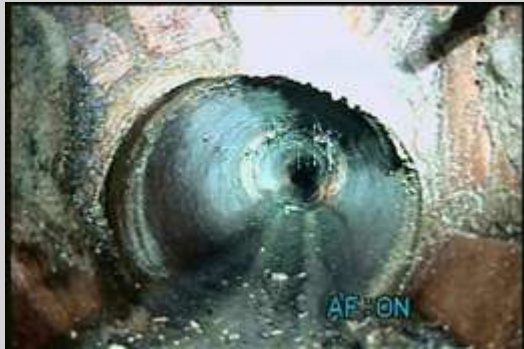
12 O'Clock Outflow

8 in. Circular Gravity Sewer
Pipe Out @ 12 O'Clock

Invert Depth: 7.66 (ft.) Flow Characteristics: **Slow**

Infiltration: **None** Pipe Seal Cond: **Unknown**

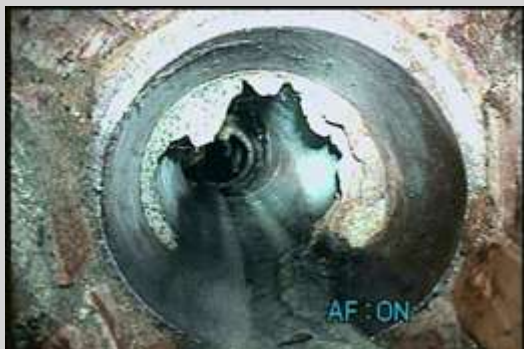
6 O'Clock Inflow

8 in. Circular Gravity Sewer
Pipe In @ 6 O'Clock

Invert Depth: 7.25 (ft.) Flow Characteristics: **Slow**

Infiltration: **None** Pipe Seal Cond: **Unknown**
